# Manhole Inspection Summary

Manhole # S19GG\_012MH

Insp Date: **6/13/07 10:22 AM**

**Location** Address: **1618 RUPP ST**

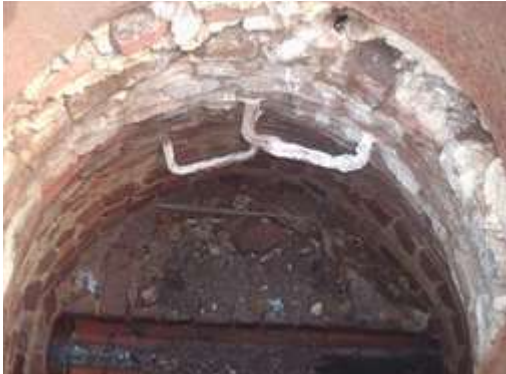
Defect 1

Count: **2** Missing: **0** ☒ **Corroded**

CORRODED STEPS

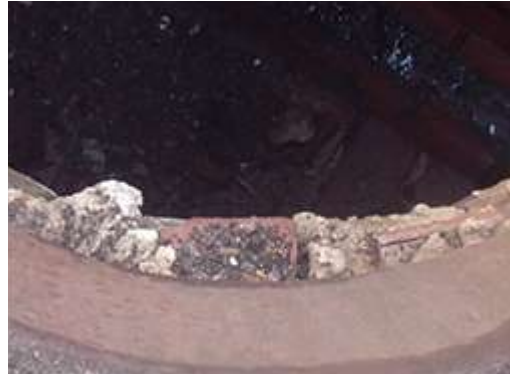
Defect 3

Offset: **1** (in.)

FRAME OFFSET

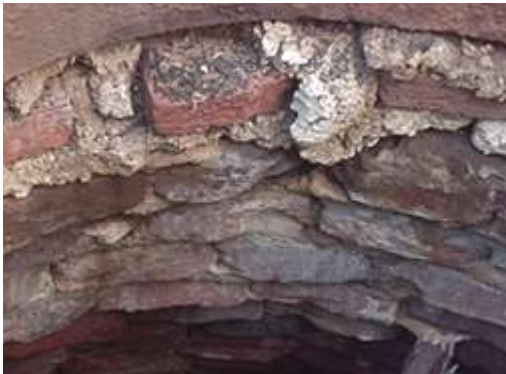
Defect 2

Condition: ☐ Sound ☐ Cracked ☐ Root Intrusion ☐ Loose Brick ☒ **Deteriorated**

DETERIORATION OF CHIMNEY

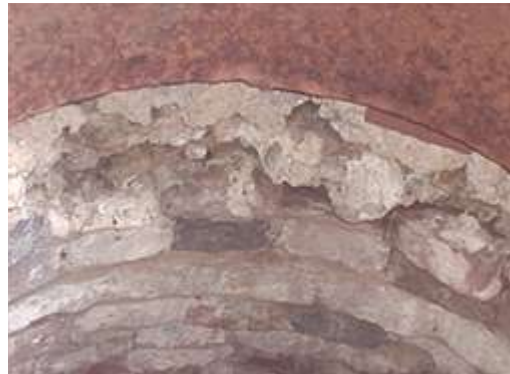
Defect 4

Condition: ☐ Sound ☐ Cracked ☐ Root Intrusion ☐ Loose Brick ☒ **Deteriorated**

DETERIORATION OF CORBEL

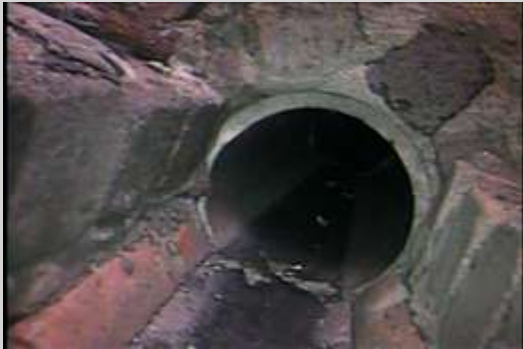
12 O'Clock Outflow

Pipe Height: **8.4** (in.) Rod and Bar (Angled)  
Pipe Material: **Clay** ☐ Pipe Lined  
Invert Depth: **6.06** (ft.) Flow Characteristics: **Slow**  
Deposits: ☒ None ☐ Mud ☐ Sludge ☐ Debris ☐ Grease  
Silt Depth: (in.) Deposits Extent:  
Infiltration: **None** Pipe Seal Cond: **Sound**

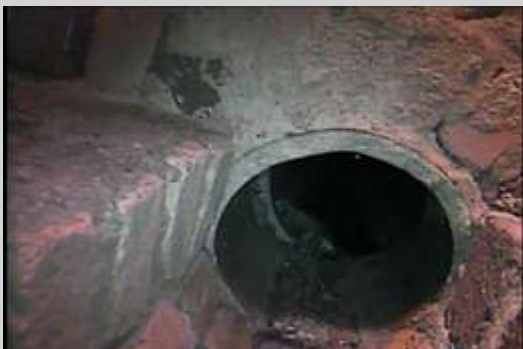
3 O'Clock Inflow

Pipe Height: **8.4** (in.) Rod and Bar (Angled)  
Pipe Material: **Clay** ☐ Pipe Lined  
Invert Depth: **5.92** (ft.) Flow Characteristics: **Slow**  
Deposits: ☒ None ☐ Mud ☐ Sludge ☐ Debris ☐ Grease  
Silt Depth: (in.) Deposits Extent:  
Infiltration: **None** Pipe Seal Cond: **Sound**

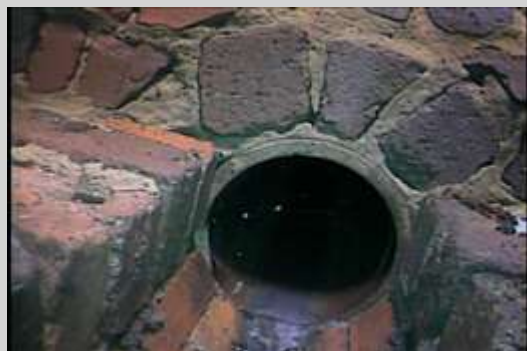
6 O'Clock Inflow

Pipe Height: **8.4** (in.) Rod and Bar (Angled)

Pipe Material: **Clay** ☐ Pipe Lined

Invert Depth: **5.94** (ft.) Flow Characteristics: **Slow**

Infiltration: **None** Pipe Seal Cond: **Sound**
